# ST. PAUL'S CATHOLIC CENTER FACILITY ASSESSMENT

NOVEMBER 29, 2012

**St. Paul's Catholic Center  
Facility Assessment  
D&A# 12105  
NOVEMBER 29, 2012**

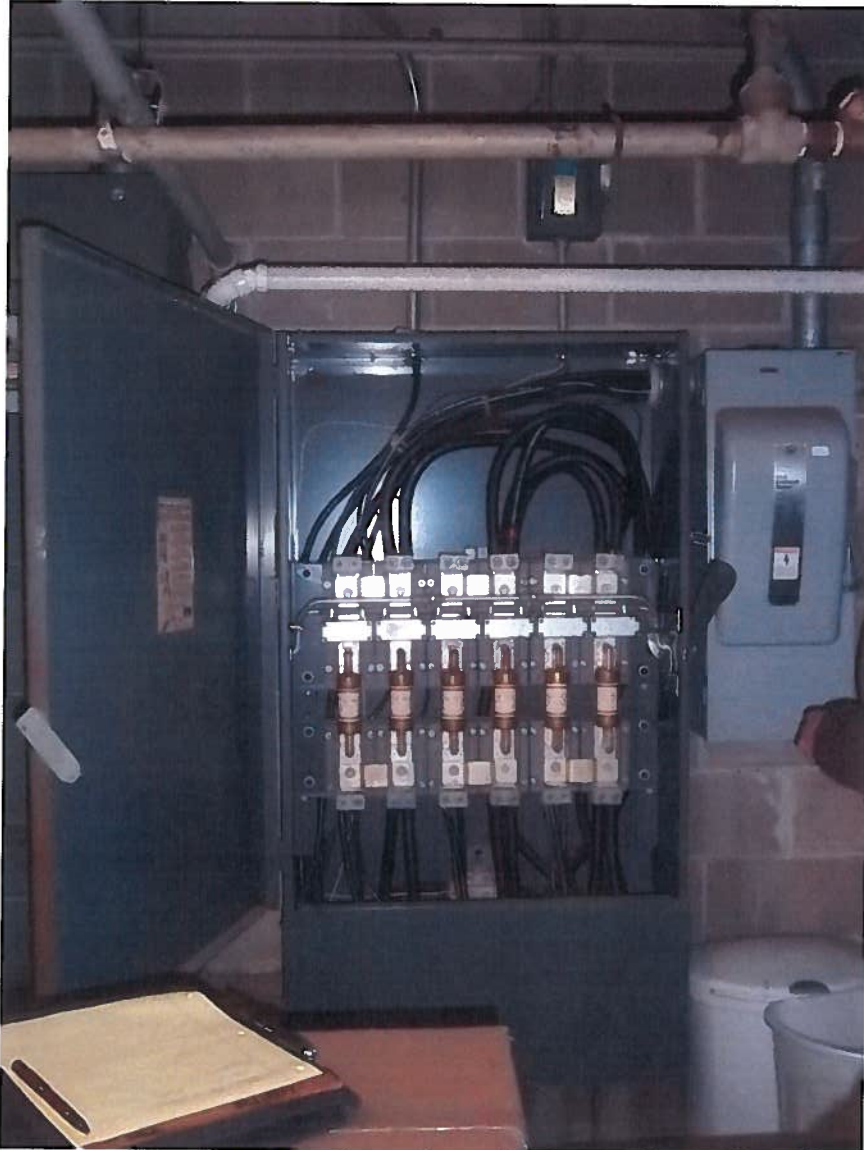
Power Distribution: (In Boiler Room)

120/208v, 3P, 4W, 800A main fused switch (fused with twin 400A fuses/phase) fed from a dedicated 150 KVA pad mounted transformer.

The line side is tapped with 1-100A 3P fused disconnect feeding the elevator and 1-200A 3P fused disconnect feeding Panel F. The load side is tapped by 30A 3P fused disconnect (no label). A main 800A disconnect feeds the ITE clampmatic 800A "fuse center" disconnect section (120/208V, 3P, 4W).

Various code violations still exist as pointed out in the F&G report dated October 13, 2008. At the time of the R.E. Dimond visit, one of the violations (the temporary dimmer panel feed with 'SOW' cord) had been removed. The other violations noted (common neutrals and grounds in panels, breakers with more than one conductor, and no grounding bushings at panels) still exist and should be corrected.

In addition it is recommended that the parallel fused service entrance switch be replaced with an 800A main fused switchboard to eliminate parallel fuses and provide additional fused switches to eliminate the various taps on this switch. Estimated cost \$25,000.
